OFFICE OF INSPECTOR GENERAL

Management Alert – Immediate Removal of All Detainees from the Torrance County Detention Facility

March 16, 2022
OIG-22-31

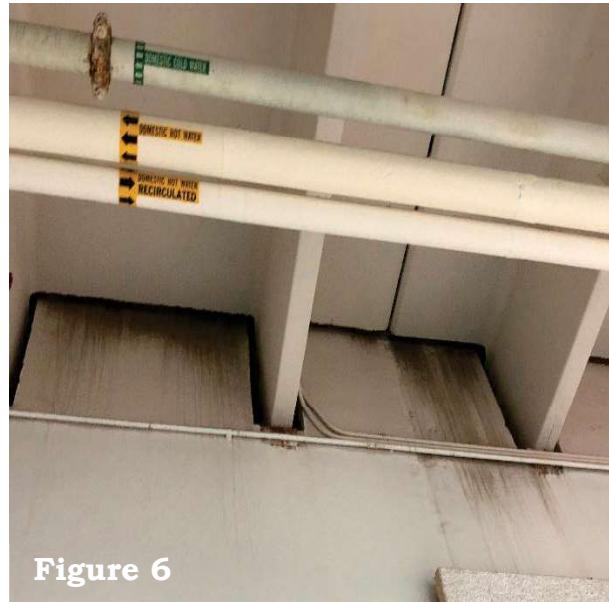
Figure 5

In addition, we encountered mold and water leaks throughout the facility (see Figures 5 and 6 for illustrative examples). These issues exacerbate unsanitary conditions and can lead to slips and falls by detainees or facility staff. Further, it could also lead to health issues for both detainees and staff breathing in the mold. Work orders showed that most problems we observed during our inspection went unresolved for 12 or more days.

Figures 5 and 6. Leaking Detainee Cell Sink and Toilet, with Floor Mold in a Vacant Cell Located in an Occupied Housing Unit (left) and Housing Unit Ceiling Mold from Leaks (right)

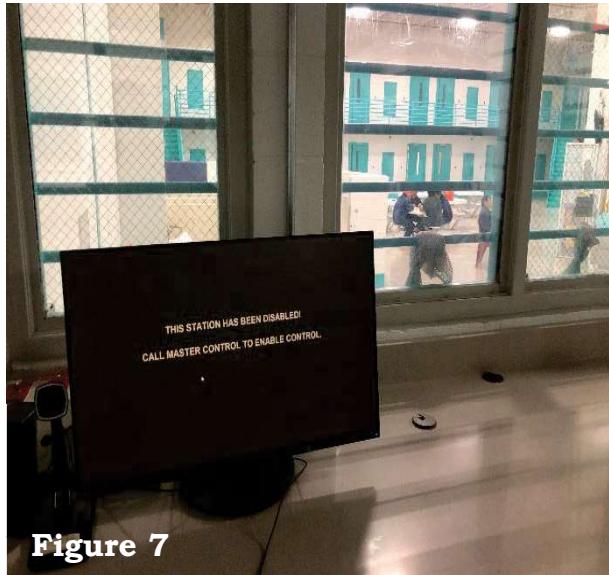
Figure 7

detainees. To compound this issue, we observed control rooms that were dark and empty without posted officers (see Figure 7). Further, these control rooms had poor visibility of detainees, through multiple sets of barred and dirty windows (see Figure 8).

Figures 7 and 8. Detainee Housing Unit Control Room without Posted Officers (left) and with Poor Sight Lines through Barred and Dirty Windows (right)

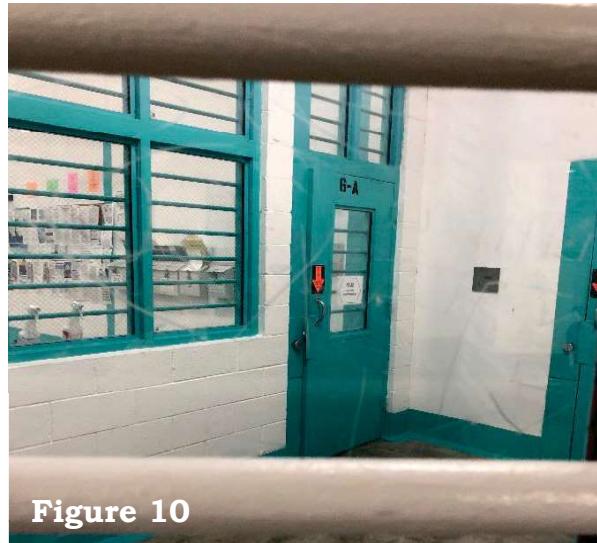
Figure 9

When questioned about these security lapses and the absence of officers at posts in the housing units or in the housing unit control rooms (see Figure 9), Torrance management explained officers in the master control room monitor housing units through cameras and electronic door systems when no officers are posted in the primary control rooms. This backup system of monitoring proved to be ineffective when we observed the entry door to a housing unit was left ajar (see Figure 10). An interviewed detainee corroborated this unsafe and unsecure environment, telling us that he felt he would be unable to get the attention of staff in the event of an emergency. We also observed unsupervised detainees in the housing units dumping buckets of water from the second story railing in what appeared to be an attempt to quickly clean the housing area.

Figures 9 and 10. Detainee Housing Unit without an Officer Posted Inside (left) and Door to Detainee Housing Unit Left Ajar (right)

We recommend that the Acting Director of ICE immediately relocate all detainees from Torrance County Detention Facility and place no detainees there unless and until the facility ensures adequate staffing and appropriate living conditions.
